DOE/EV-0032

Report on the Explosion, Fire, and Oil Spill Resulting in One Fatality and Injury on September 21, 1978, at Well 6 of Cavern 6 at the West Hackberry, Louisiana, Oil Storage Site of the Strategic Petroleum Reserve

November 1978

U.S. Department of Energy
Washington, D.C. 20545

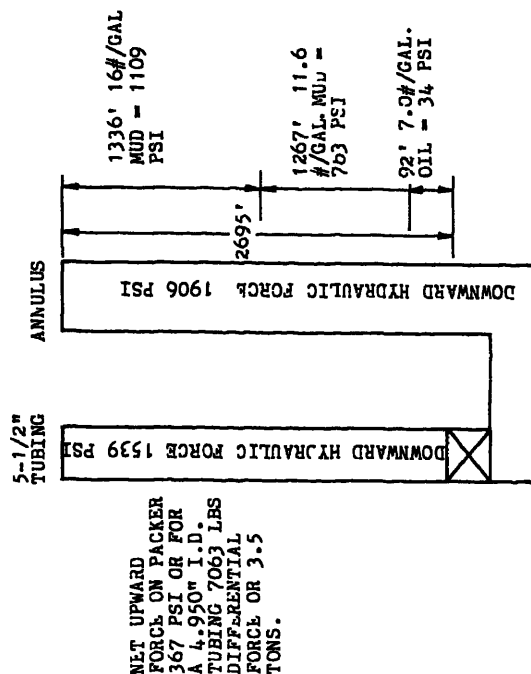
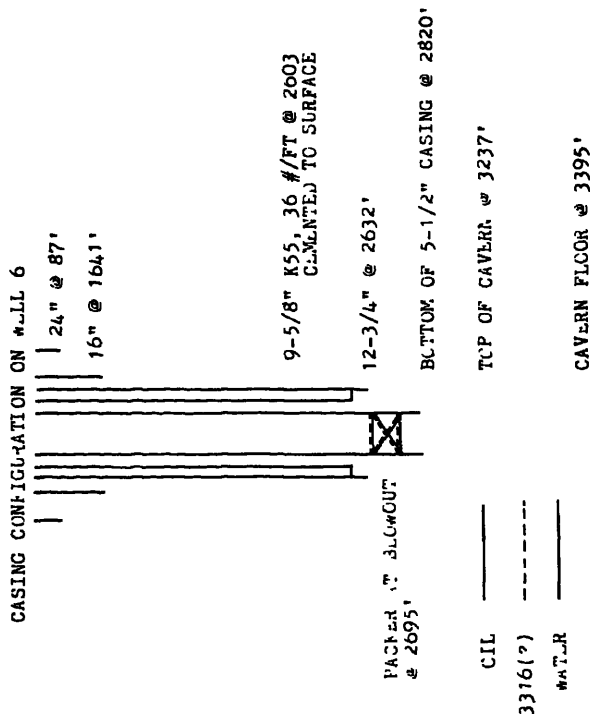
Figure 29. Hydraulic Forces When the Packer Failed

upward force when it had been previously set, it is assumed that the 7,063-pound total differential force exerted beneath the packer at that point in time, shown in Figure 29, caused the packer to slip up the hole and ultimately to be ejected from it.

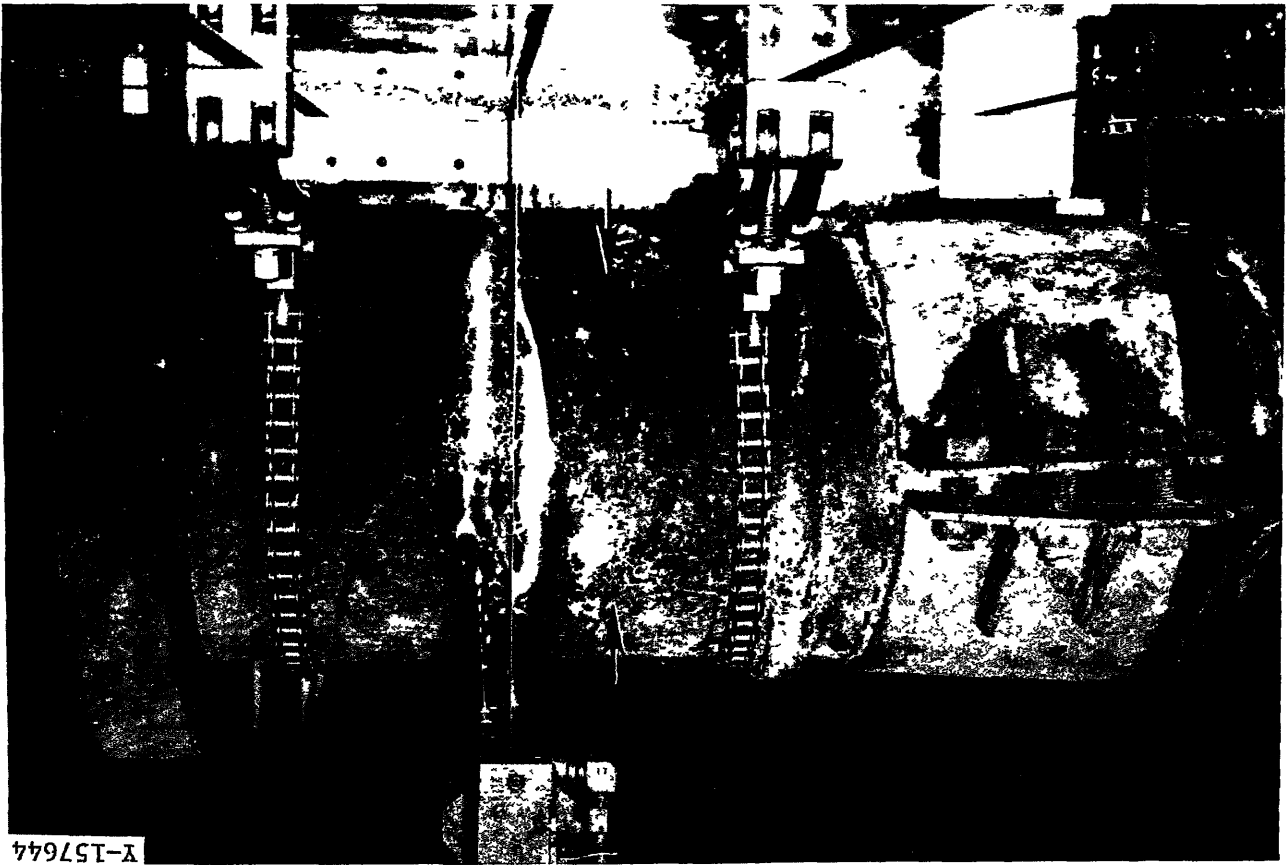
Fig. 2. Wellhead Assembly as Delivered to ORNL. Assembly is positioned for cutting. Arrows point out location of internal weld between 0.24-m-diam (9 5/8-in.) pipe and outer casing. Cutting lines are indicated.

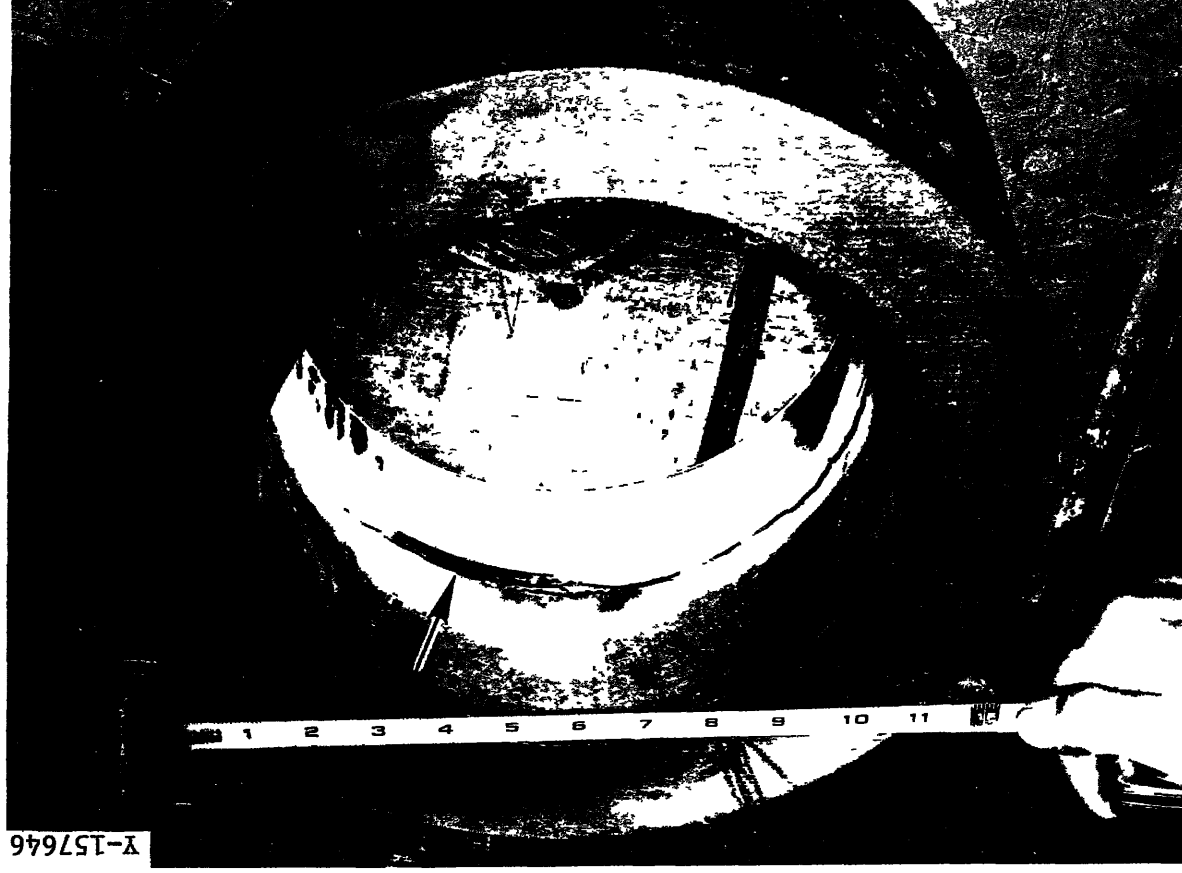
Fig. 5. Dye-penetrant inspection of internal bore weld reveals gross cracking and through-weld leak.

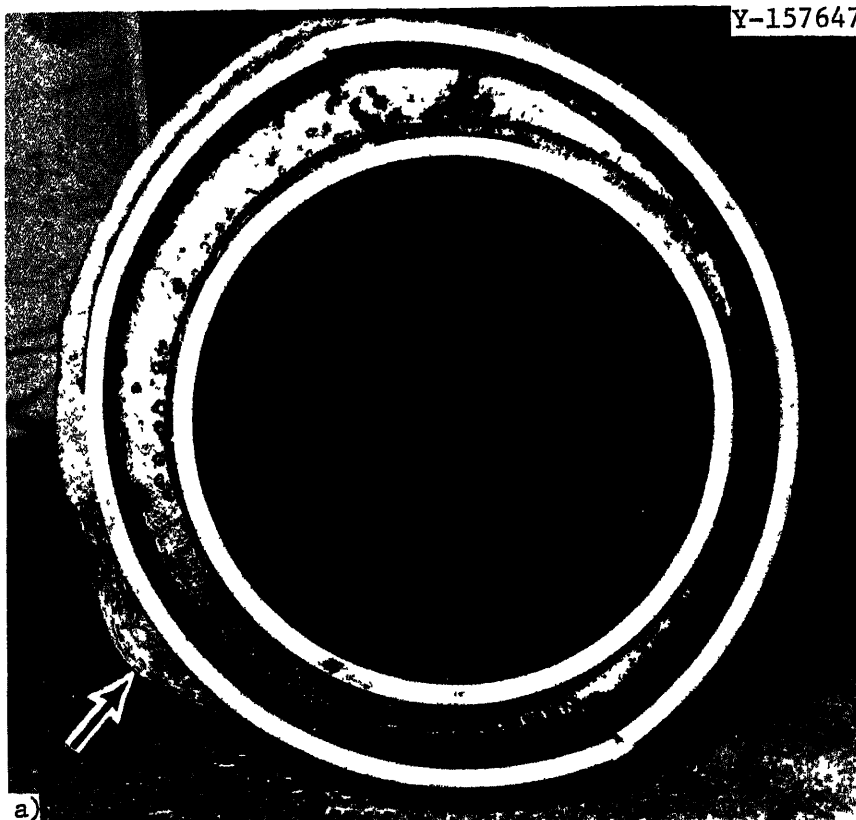
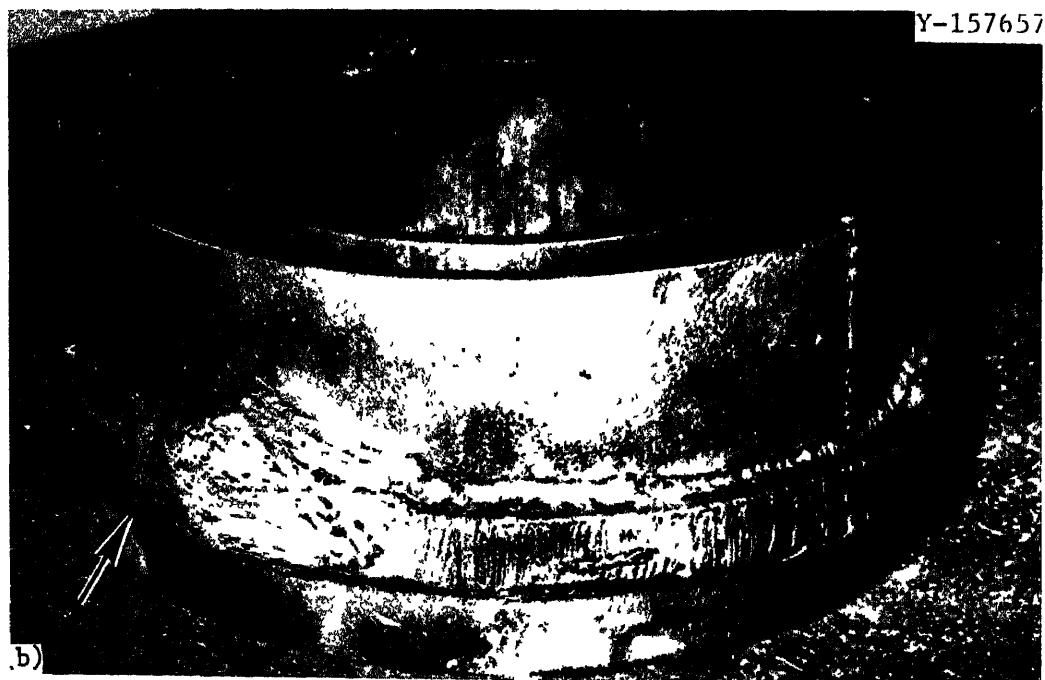
Fig. 8. Two Views of Section of Wellhead Assembly Containing Flame Cut Spacer Ring (Arrows) Which had been Welded Between the Heavy Walled Wellhead and Outer Casing (see Fig. 3, Welds C and D).

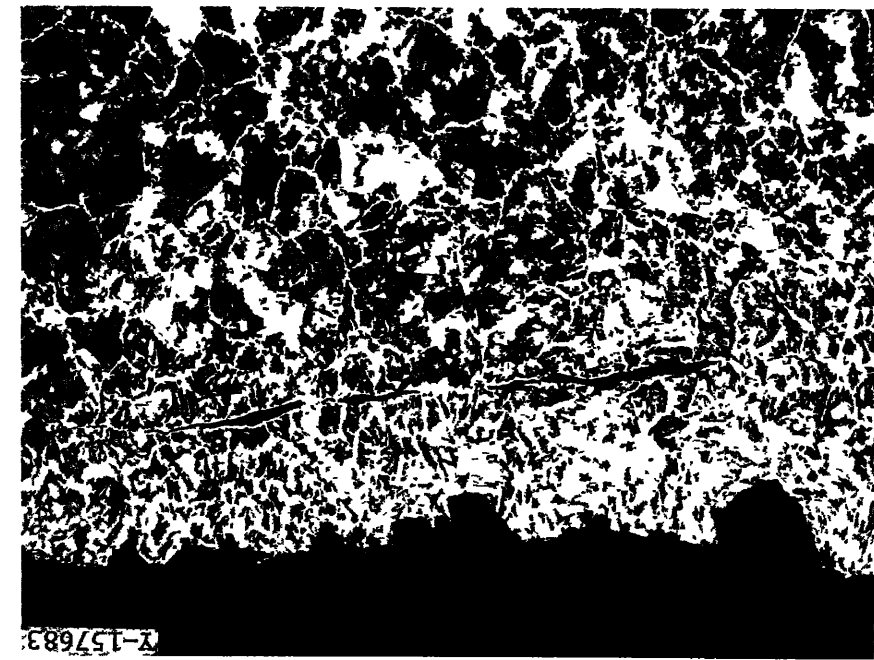
Fig. 14. Photomicrograph of Fracture Edge Showing Small Fissure Slightly Below the Plane of Fracture.

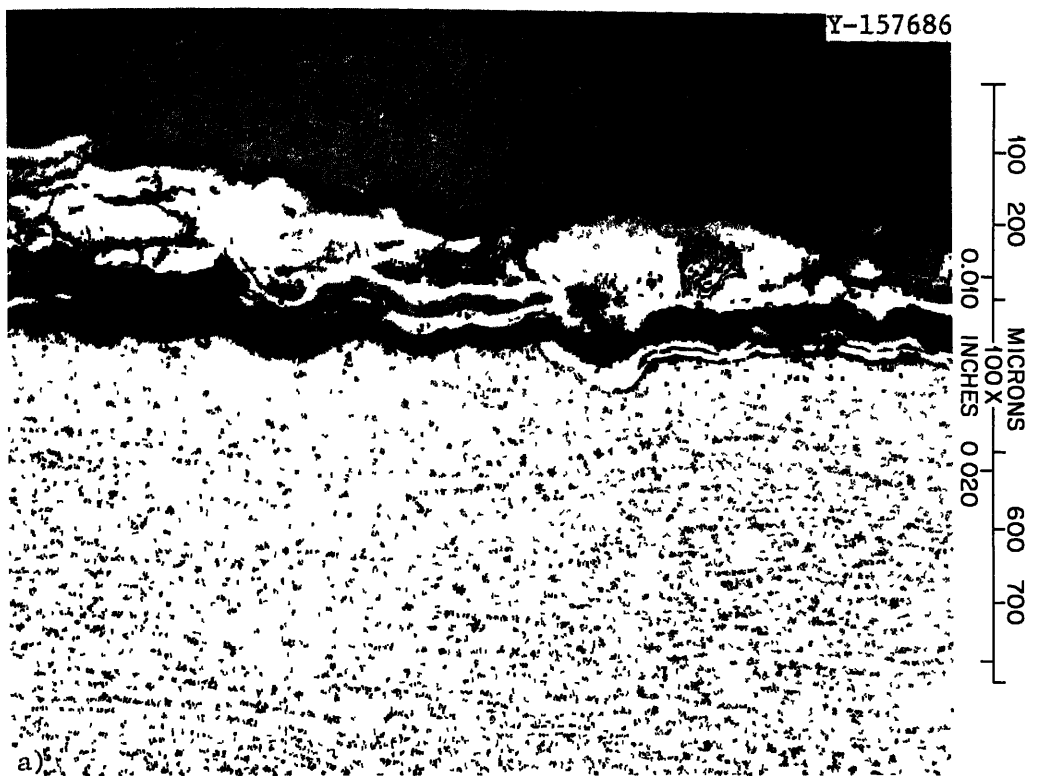
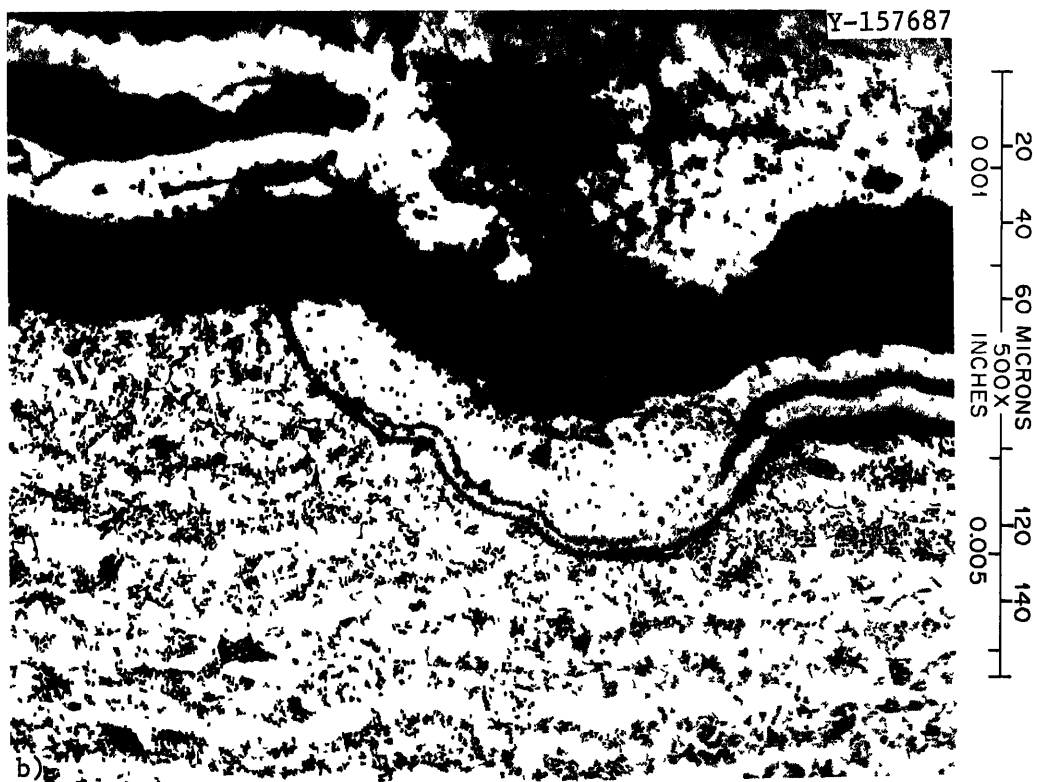
Fig. 17. Microstructure of Pipe 14. Photomicrograph was made at exterior surface. Some oxidation can be seen, but the wall is essentially undamaged.

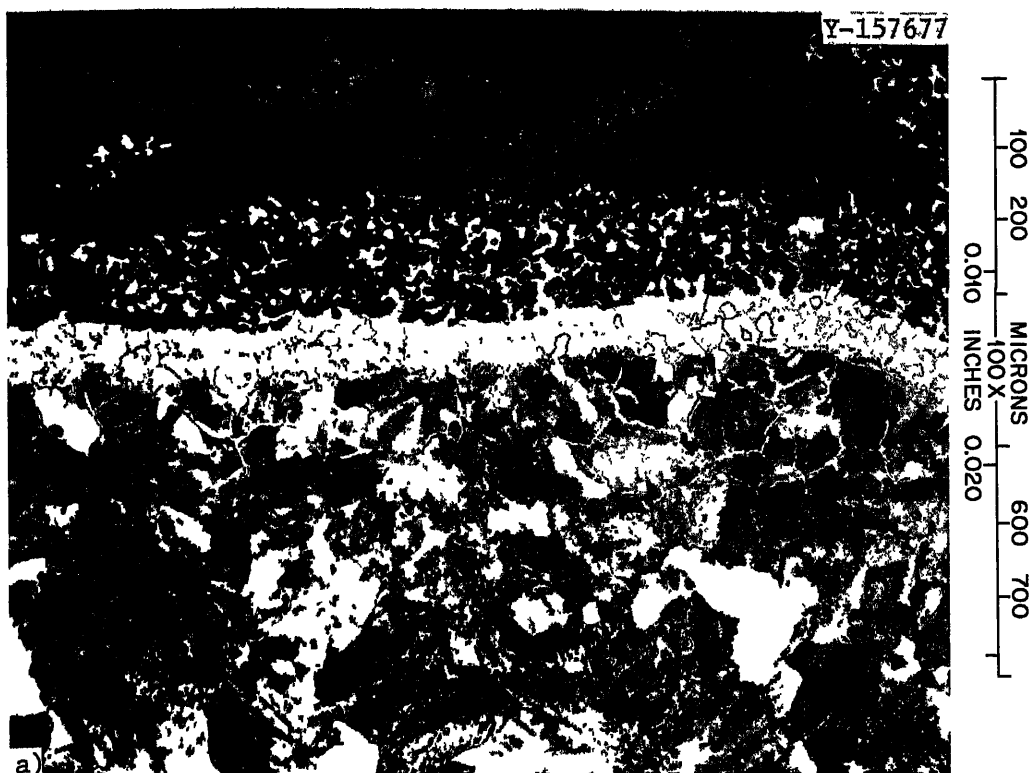
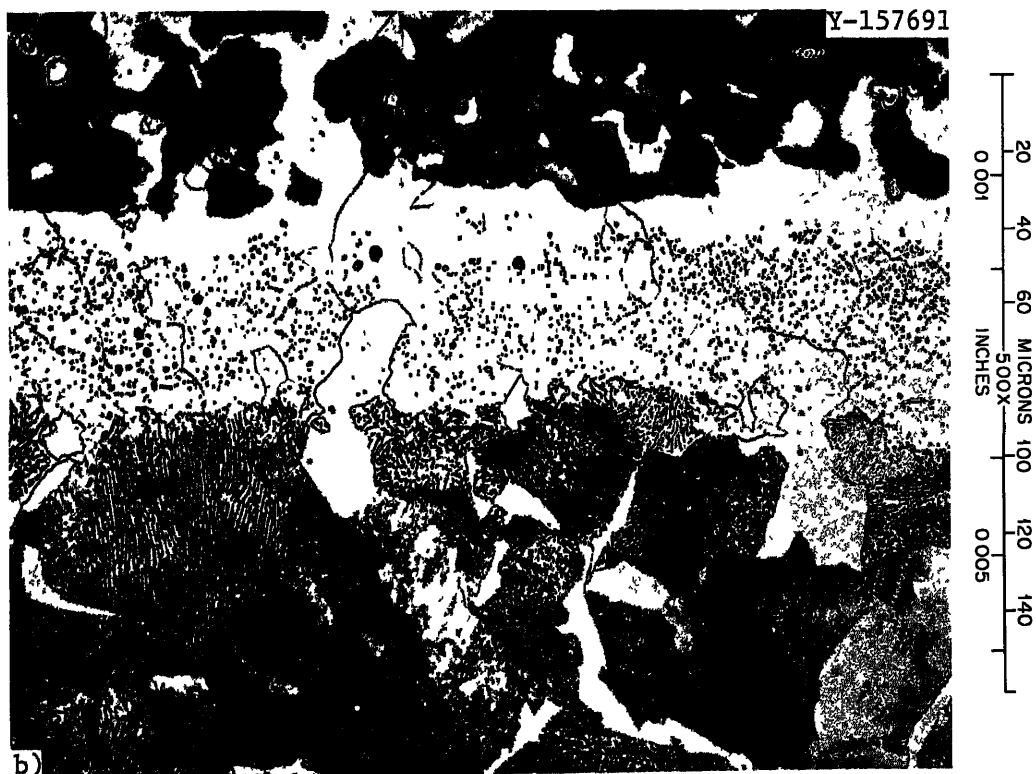
Fig. 21. Microstructure of Pipe 2. Note the carburized condition of the microstructure as compared with Pipe 14 (Fig. 17). A decarburized layer at the inner surface of the pipe wall near a reaction product can be seen.

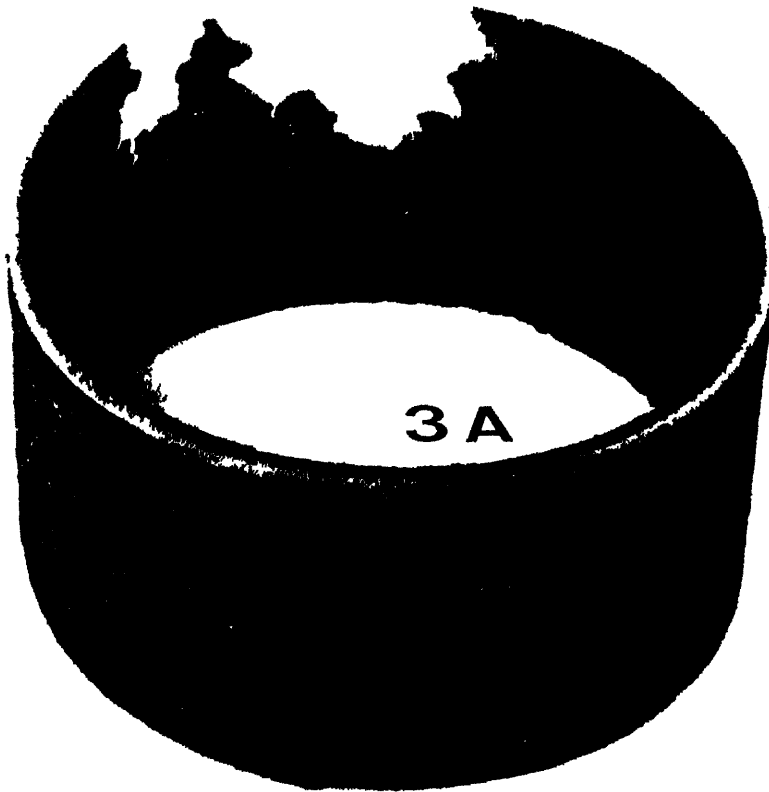
Fig. 24. Segment of Pipe 3 Showing a Hole and Gross Oxidation/Corrosion.

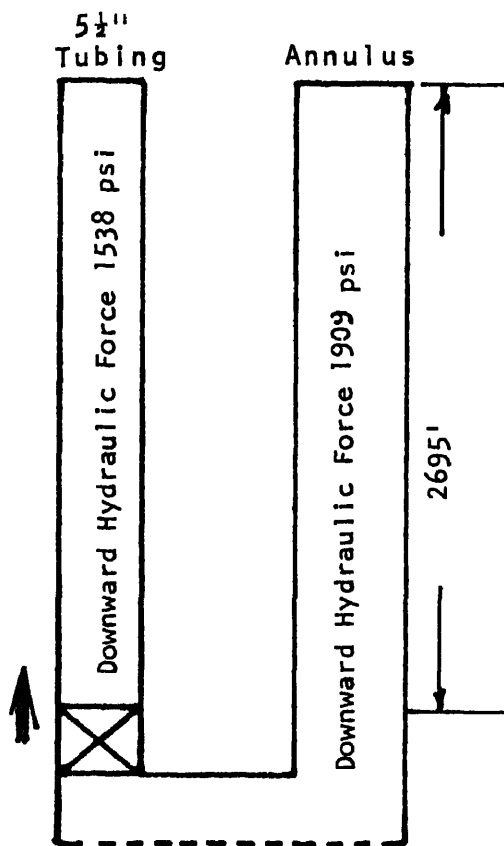
Figure 11.

Well 6 As A "U" Tube
HYDRAULIC FORCES WHEN THE PACKER FAILED

Net Upward
Force on Packer
371 psi
or for a
5" I.D. Tubing
7270 Pounds
or
3.6 Tons
